ENGINEERING GEOLOGY ASSESSMENT OF
SLOPE INSTABILITY ON FOREST LANDS
IN SOUTH WESTLAND

A thesis
submitted in partial fulfilment
of the requirements for the Degree
of
Master of Science in Engineering Geology
in the
University of Canterbury
by
MARK J EGGERS

University of Canterbury
1987

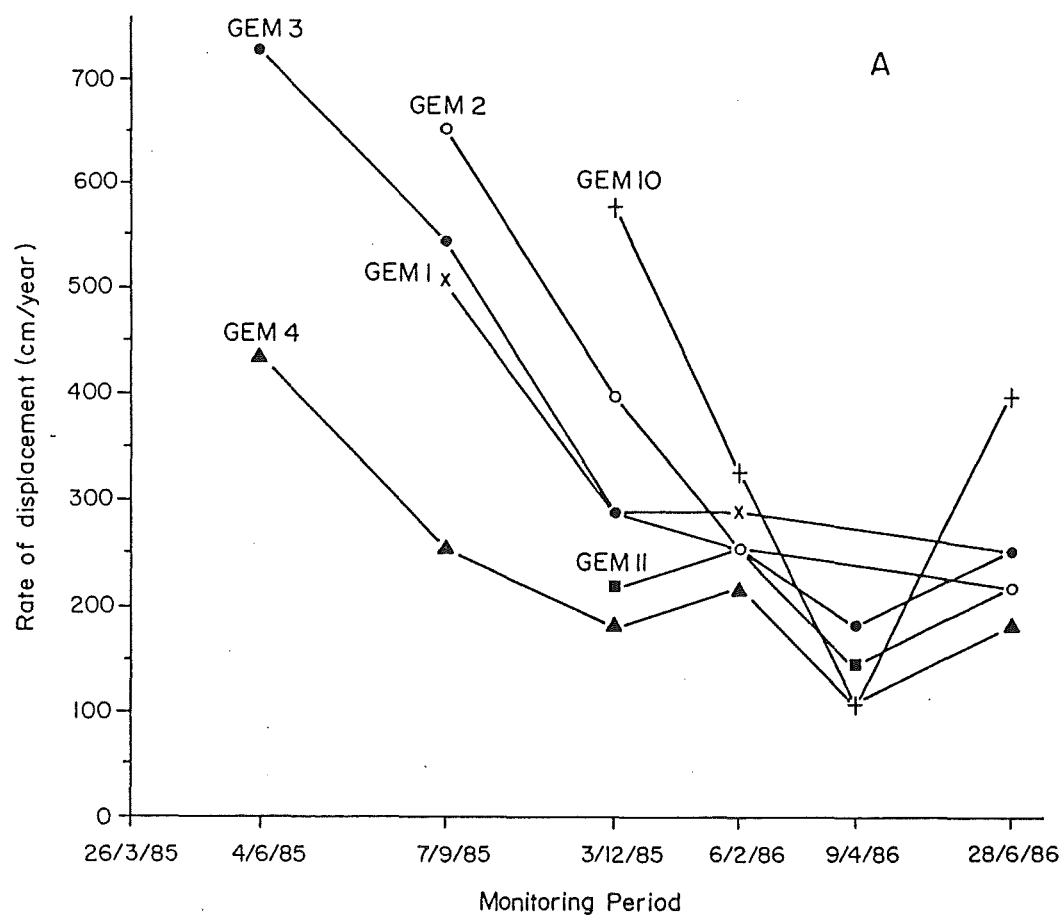
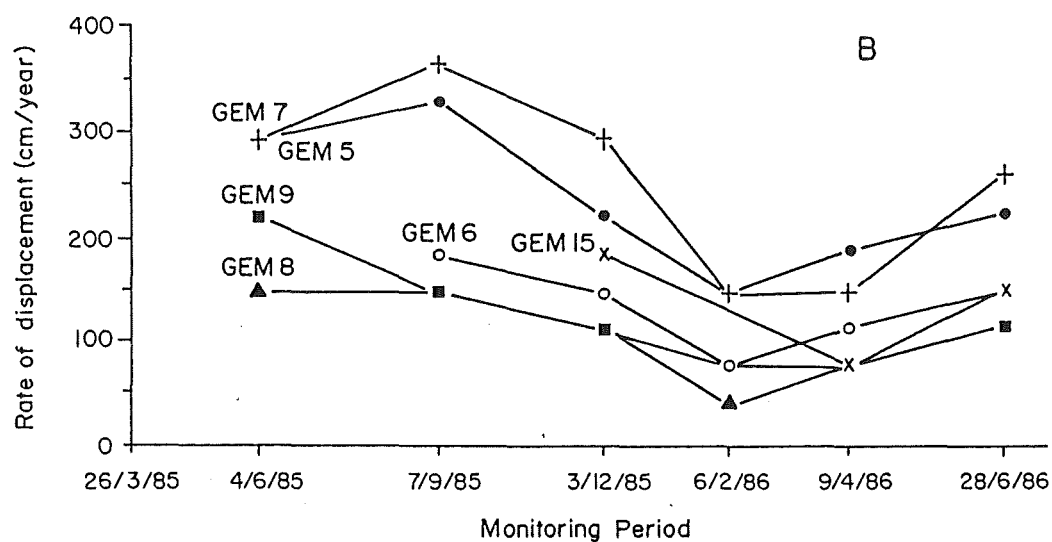
Fig. 6-20: Change in rate of total (recent) displacement during the monitoring period 26/3/85 - 28/6/86 for the Grave Earthflow

This pattern of movement is interpreted to be the response of the earthflow to unloading of toe support in December 1984 when the road batter was cut and benched (see Section 6.3.2). Removal of toe support in effect caused an instantaneous acceleration in movement rates in the foot region, which then retrogressively moved towards the head region. Monitoring, which began in March 1985 (3 months later), picked up the deceleration of movement rates from the initial high value caused by the instantaneous acceleration, and this obscured any other variation in movement rates which may have been present. Near the end of the monitoring period, movement rates had declined to what is inferred to be "normal" levels that seemed to be influenced by seasonal variations, as discussed below.

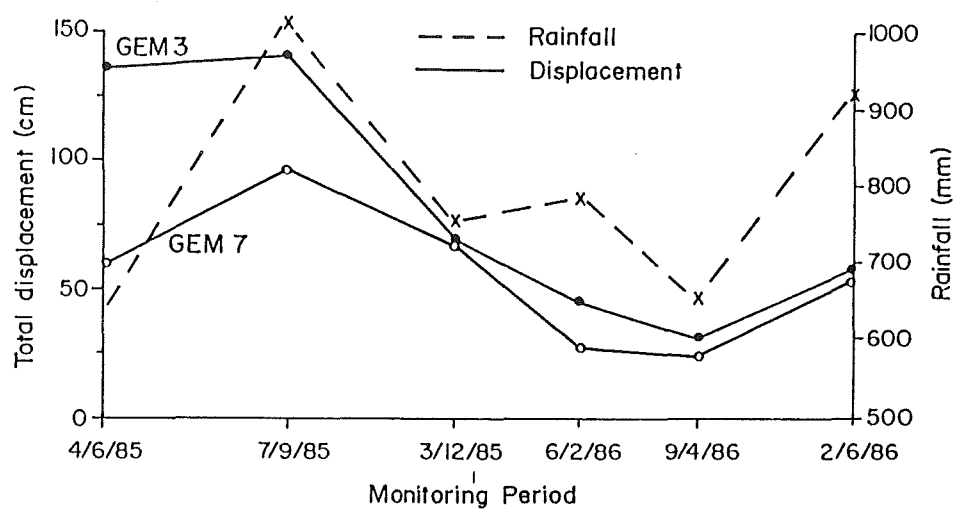
Figure 6.21 illustrates a correlation of rainfall with total displacement during the period of earthflow monitoring. Rainfall data, taken from daily observations made at the new Haast station (station number F39802), is plotted as total recent rainfall since the last survey, as is total displacement. The two total displacement curves, one each from the foot and head regions, show a similar pattern to the rate curves in Figure 6.20, declining from a high to a low value before increasing to a moderate ("normal") level. The rainfall curve shows a similar pattern, with a winter maximum coinciding with the maximum displacement value (on 7/9/85), and the summer minimum coinciding with minimum displacement (on 9/4/86). There is no lag or delay in movement following rainfall variations, suggesting that rainfall effects on movement are immediate. However, this apparently good correlation is interrupted by two anomalies:-

1. GEM 3 total displacement does not recover to its 4/6/85 high on 28/6/86, and;
2. an increase in rainfall during the period 3/12/85-6/2/86 did not produce a corresponding increase in movement.

Fig. 6-21: Correlation of rainfall with total (recent) displacement during the monitoring period for the Grave Earthflow

The first anomaly was caused by the effect of unloading toe support on movement during the 1985 season which produced an unusually high displacement rate. The second anomaly is probably due to the fact that either movement was still primarily being influenced by the deceleration process, overriding rainfall effects, or possibly the increase in rainfall may not have been sufficient to increase movement rates, suggesting that there is a threshold value of rainfall that causes movement. The most likely explanation would be a combination of these two ideas.

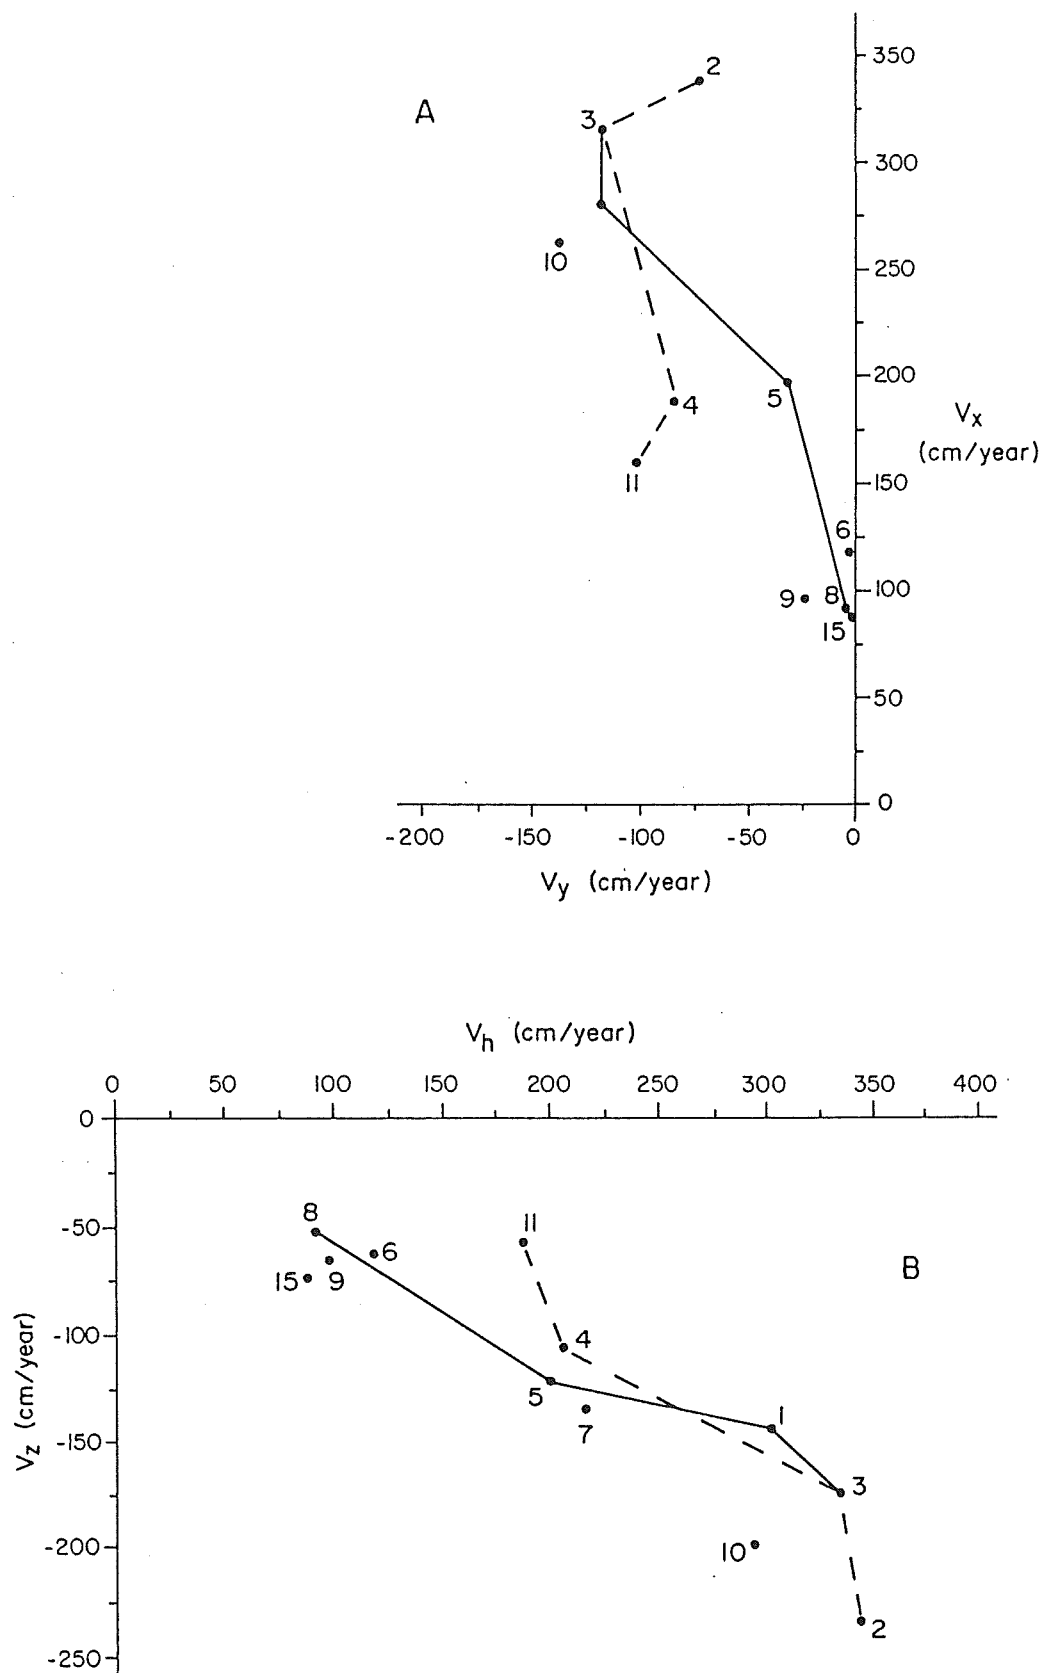
Fig. 6.22: Hodographs of average displacement rates of monitoring stations on the Grave Earthflow, measured between 26/3/85 - 28/6/86

1. Stations GEM 15,8,5,3 and 1 are located along a line parallel to the earthflow axis. They plot as rectilinear hodographs with the foot region stations (3 and 1) showing the greatest movement and the head region stations (15 and 8) showing the least. This is indicative of a retreating flow failure with the seat of failure located in the lower part of the slope.
2. Stations GEM 2,3,4 and 11 are located across the earthflow axis with their hodographs showing a part rectilinear, part fan-like arrangement indicating failure is part-rotational, part-translational.

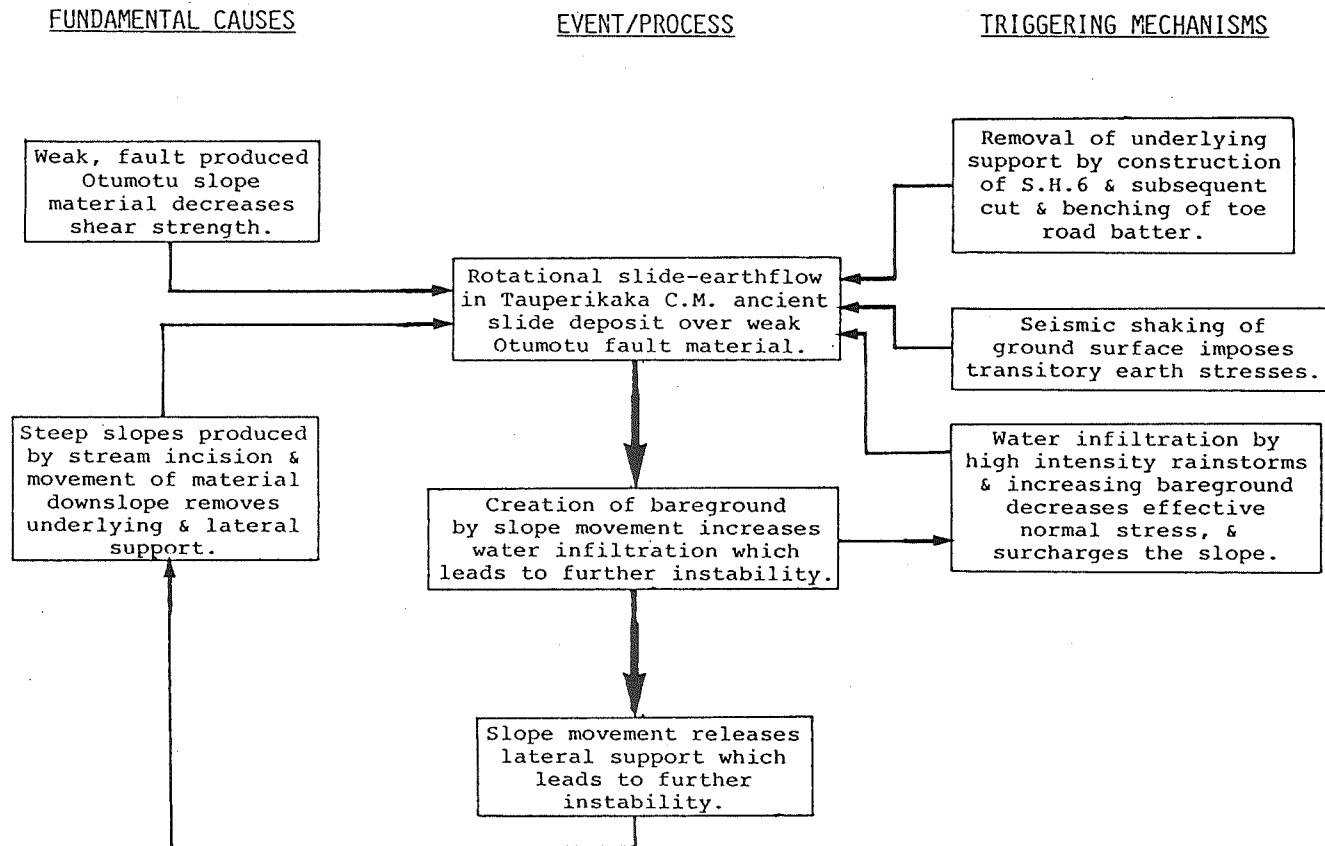
Factors contributing to failure can be separated into fundamental causes, which combine to produce a slope at limiting equilibrium (factor of safety close to 1.0), and triggering mechanisms, which initiates the critical slope to fail. Figure 6.23 illustrates the interrelationships of causes of the Grave Earthflow and these are described below under the two above headings:-

Fig. 6.23 Model of interrelationships between factors contributing to failure.

Five potential remedial measures are recognised for the Grave Earthflow:-

1. dewatering, using surface and subsurface drainage;
2. planting of trees;
3. buttressing of toe;
4. relocation of highway, and;
5. maintaining the present situation.

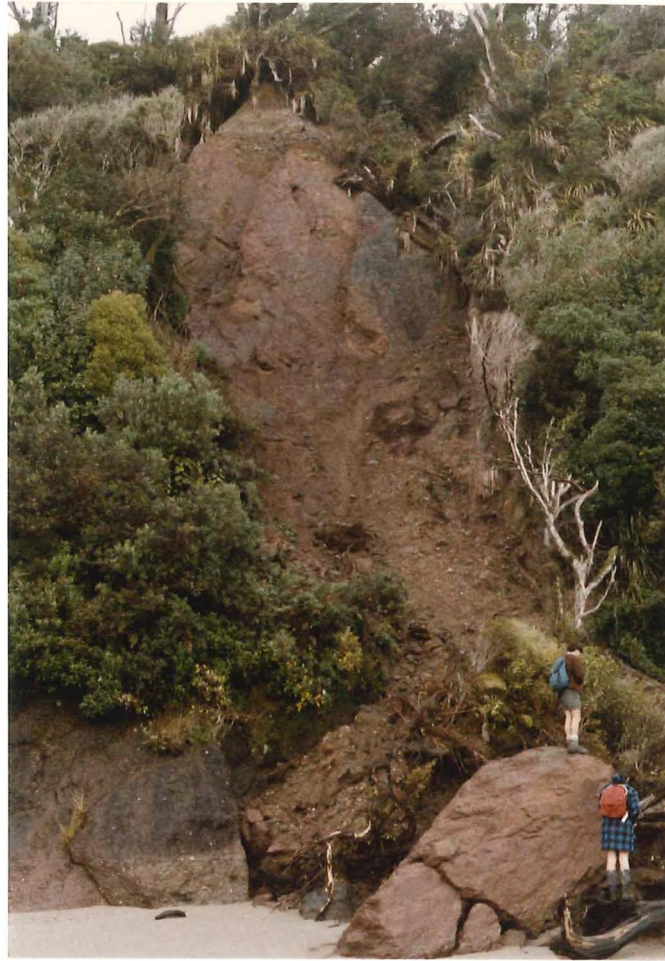
The most common mode of slope failure is rock fall on oversteepened seacliffs in Otumotu Formation and Tokakoriri Formation bedrock. Seacliffs in Otumotu Formation are not presently undergoing active sea erosion and are partly degraded and revegetated. Figure 6.25 illustrates rock fall in cobble conglomerate of the lower Otumotu Formation, which has been controlled by rock defect orientation.

Fig. 6.25 Rock fall in lower Otumotu Formation bedrock on seacliffs north of Otumotu Point.

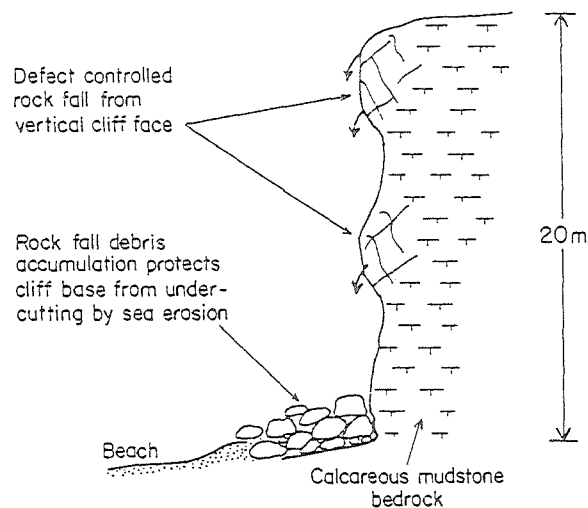
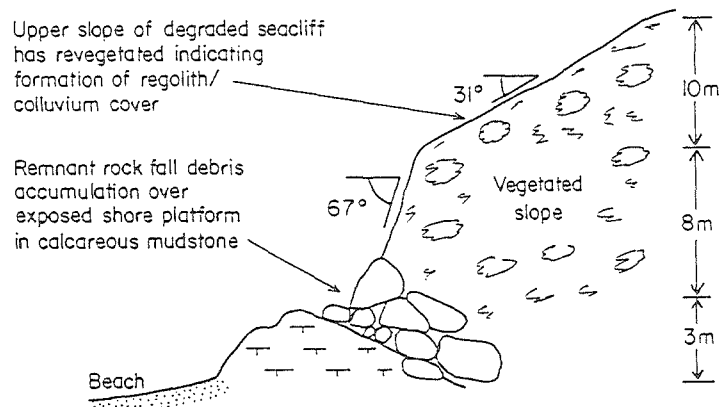
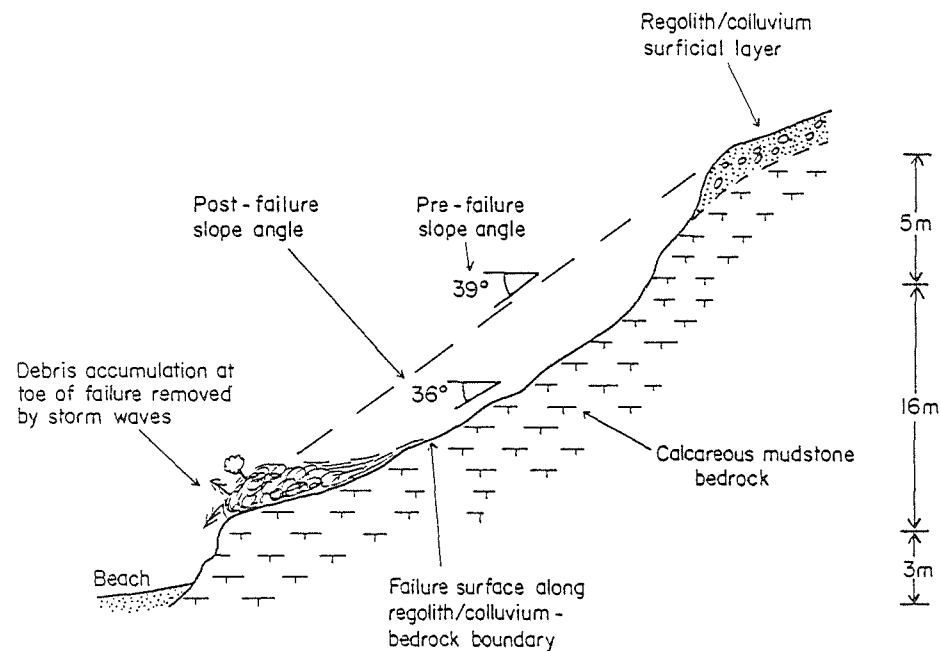
Seacliffs in calcareous mudstone of the Tokakoriri Formation are undergoing active sea erosion, which undercuts the base of the slope causing defect controlled rock fall (Fig. 6.26a). Rock fall debris, which accumulates at the base of the slope, protects the cliff face from further erosion and oversteepening, thereby allowing the slope to grade to a more stable angle (Fig. 6.26b). In places this ancient, degraded seacliff slope setting has accumulated a surficial layer of regolith/colluvium which undergoes shallow debris slide failure along the regolith/colluvium - bedrock interface (Fig. 6.26c).

FIG. 6.26: Sketch diagrams of the three coastal slope settings recognised in Tokakoriri Formation bedrock between Otumotu and Flaggly Points

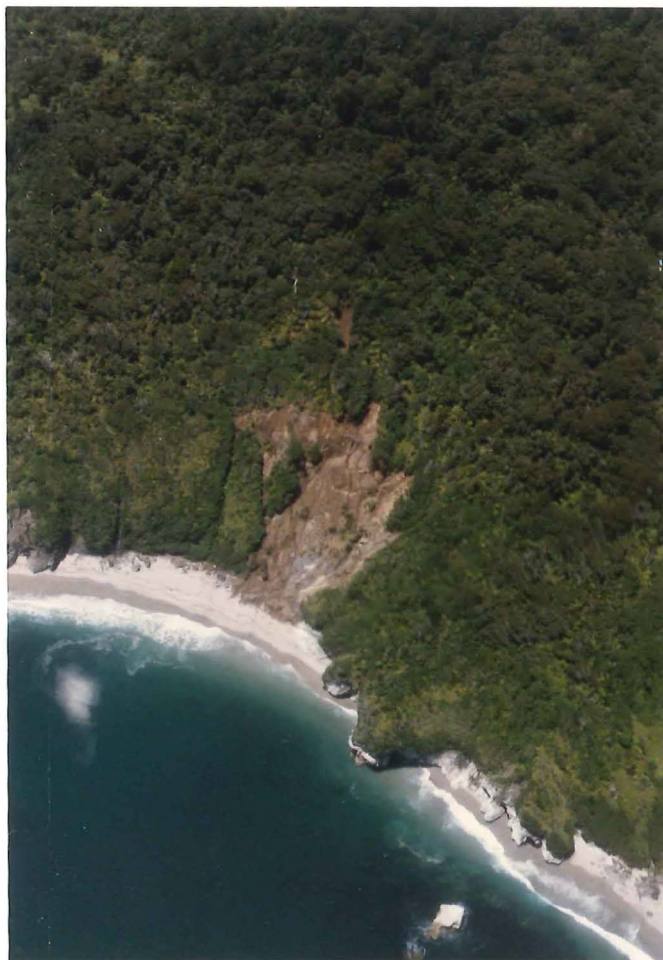
On the northwestern side of Flaggy Point a deep-seated rock slide has occurred on coastal slopes along a carbonaceous mudstone layer which is interpreted as a low angle thrust fault between Tokakoriri Formation and lower Abbey Formation limestone (M. Aliprantis pers. comm.) (Figs 6.27 & 6.28). Movement was by translational sliding of a single block of calcareous mudstone of the Tokakoriri Formation over lower Abbey Limestone, creating a 2-4m deep graben at the head of

Fig. 6.27 Rock slide on coastal slopes at Flaggy Point.
Oblique view looking east.

the failure. The carbonaceous mudstone thrust fault acts as an aquifer, this being evidenced by a line of water springs that emerge from the toe of the slope at beach level.

Above the main slide failure a number of secondary "sympathetic" shallow debris slide movements have occurred along the regolith/colluvium - bedrock interface. These post-date the rock slide movements, and were triggered in response to changes in slope conditions caused by the initial deep-seated movement, such as the removal of basal toe support and oversteepening of the slope.

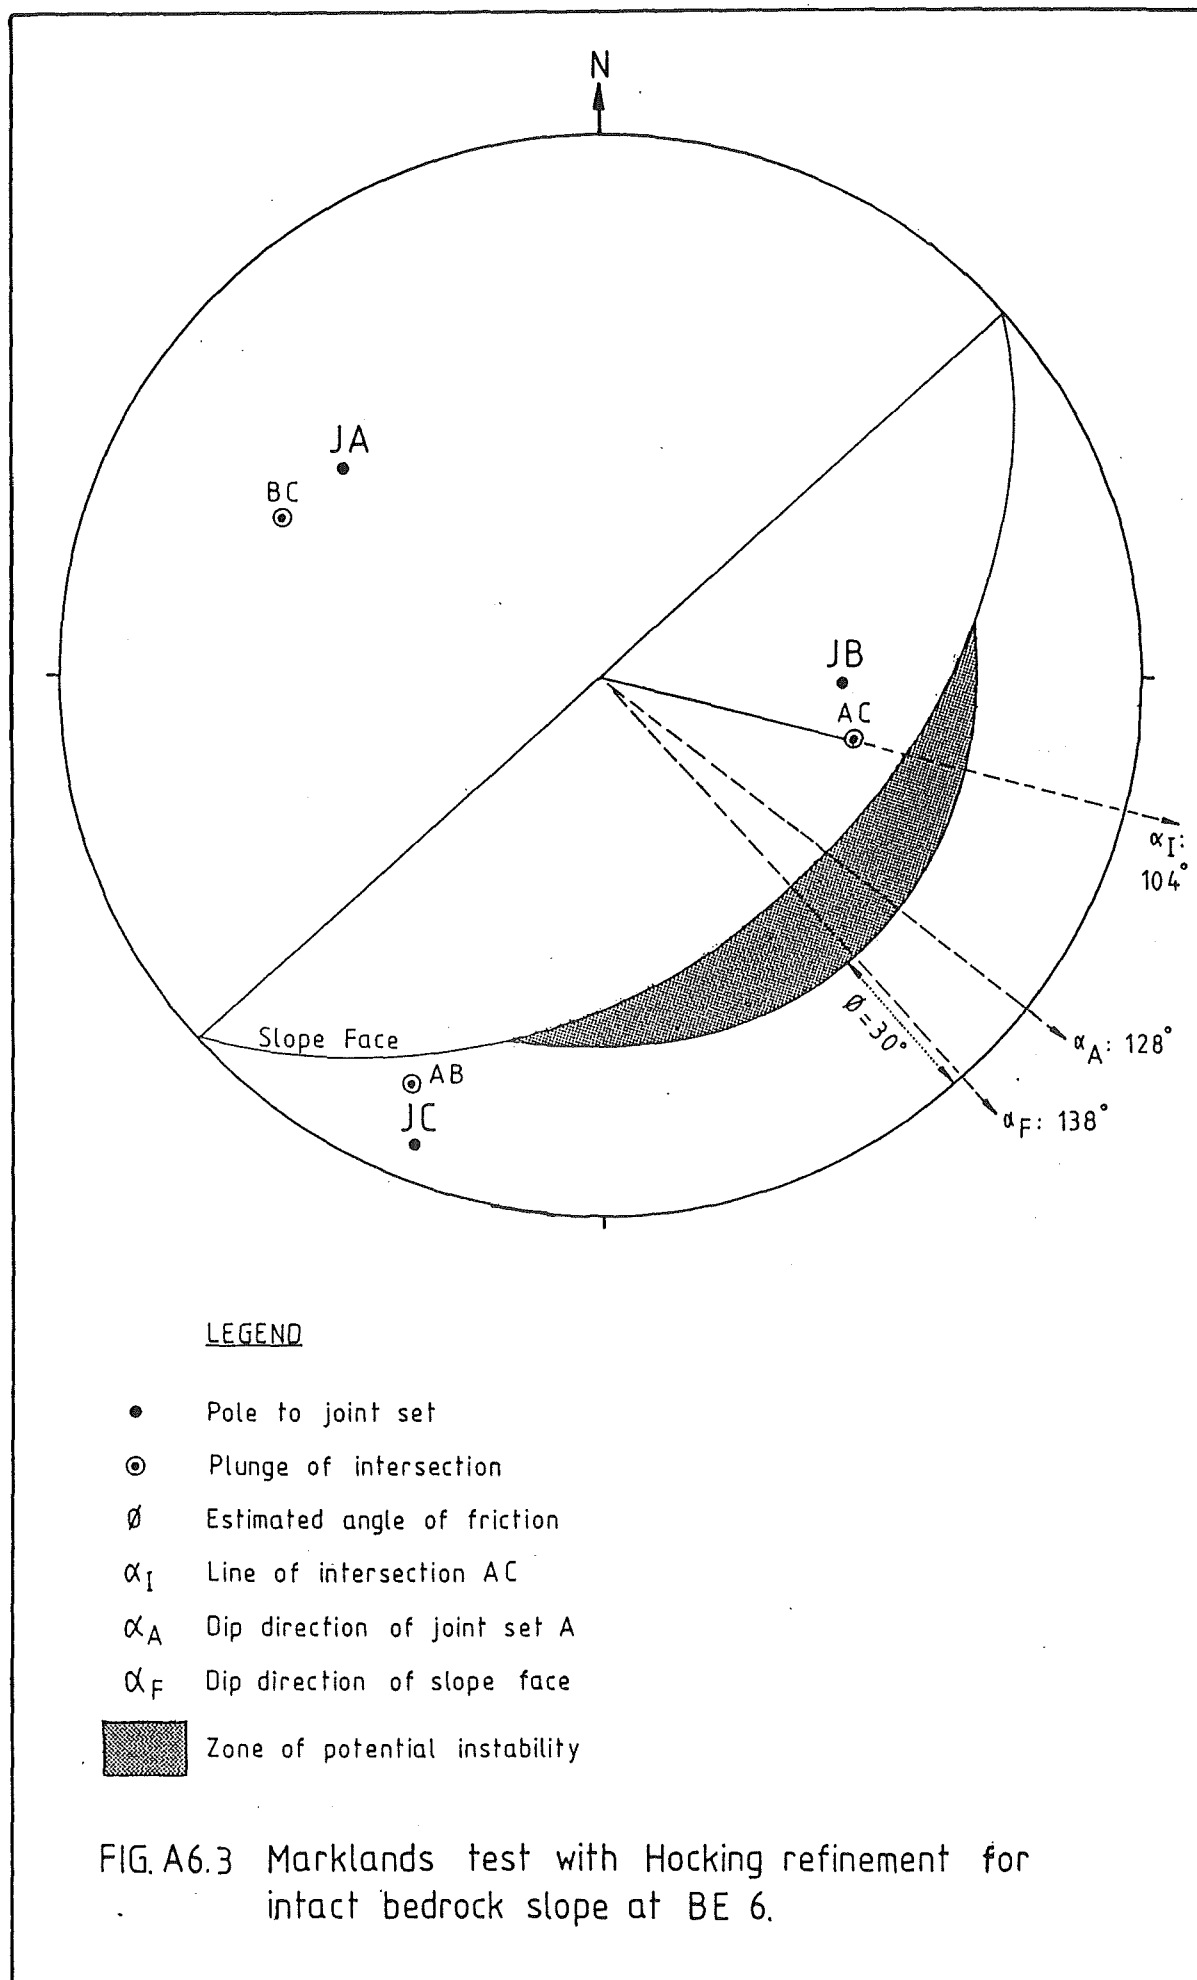
Figure A6.3 shows the Markland test for the intact bedrock slope at locality BE 6 with an average slope angle of 46° and average slope aspect of 138° (SE). A friction angle of 30° is estimated from typical values published by Hoek & Bray (1981). The test shows that the plunge of the lines of intersection do not fall in the zone of instability, however, the intersection between joint sets A and C plunges at 50° , just 4° steeper than the average slope angle.

The Hocking refinement to the Markland test shows that the dip direction of joint set A lies between the dip direction of the slope face and the trend of the line of intersection between joint sets A and C. Therefore if a portion of the rock buttress with a slope aspect not less than the dip direction of set A (128°) has a slope angle greater than 50° , failure is kinematically possible by plane sliding. If a section of the rock buttress with an aspect of less than 128° has a slope angle greater than 50° , then failure is possible

by wedge sliding along the line of intersection between joint sets A and C. Due to the dynamic nature of these slopes, either of these conditions could possibly exist and produce unstable conditions.

Figure A6.3 also shows that joint set C has the potential to produce a toppling failure, as illustrated in Figure A6.1. This situation was not observed in the field; however, toppling failure may initiate rock fall movements producing a complex rock topple-fall failure.
